Brief Commentary

Late Extrusion of an Implantable Pulse Generator of a Spinal Cord Stimulator

Pain Physician 2016; 19:E671-E674

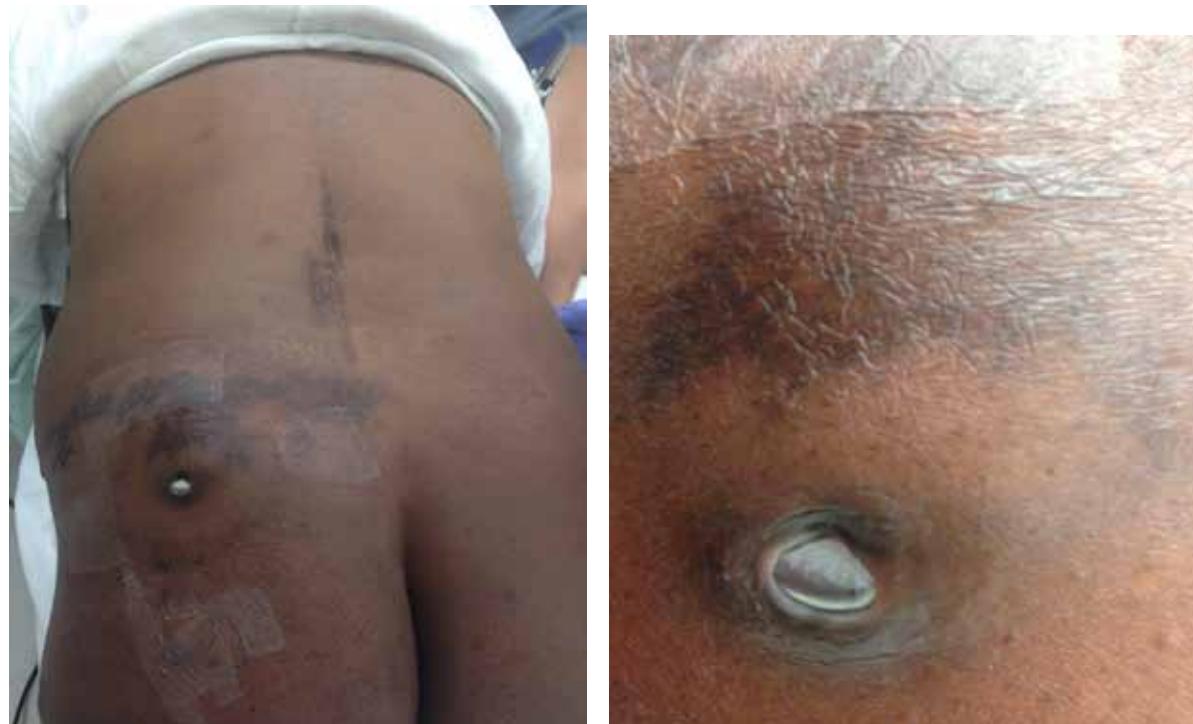
Fig. 1. Extrusion of the pulse generator.

At a routine follow-up, he complained of a "metal piece" being exposed from his buttock for one week. He denied fevers, chills, and any weight loss. He reported recent increase work as a truck driver with longer hours. He reported driving 16 hour shifts 4 days per week in the last 3 months. Upon examination, a 1 cm area of generator hardware was extruding from his left superior buttock (Fig. 1). The area was tender without any purulent fluid or erythema around the site. He was given a topical and oral antibiotic. The SCS was removed successfully 5 days later with an expected fibrous band seen around the generator (Fig. 2). An area of 0.2 cm x 1 cm of skin surrounding the area of extrusion was resected and sent for culture, which returned negative. The leads and IPG were sent to pathology for cultures, which returned negative. He completed a 14 day course of cephalexin and was instructed not to drive for 6 weeks.

The extrusion was likely due to pressure necrosis from sitting longer hours. The fibrous pocket that naturally formed and scarred around the generator could have undergone shearing near the site of implantation leading to the extrusion. Another possible cause of the extrusion could be due to larger IPG size causing strain

Clinicians should be aware of occupational hazards that could cause excessive pressure on the IPG. Patients with a SCS implanted in the gluteal region should be made aware that prolonged pressure on the IPG can lead to skin necrosis. In order to avoid this complica-

tion, clinicians may consider implanting the generator on the abdominal side although this requires longer leads and there may be difficulty in positioning the patient during the procedure. Despite the technological advances in pulse generators being rechargeable, there are patients that would still benefit from non-rechargeable pulse generators, including patients who are not electronic savvy. Rechargeable pulse generators tend to be smaller and weigh less, diminishing the risk of extrusion. There may be a technological opportunity within the neuromodulation community for developing smaller non-rechargeable pulse generators.

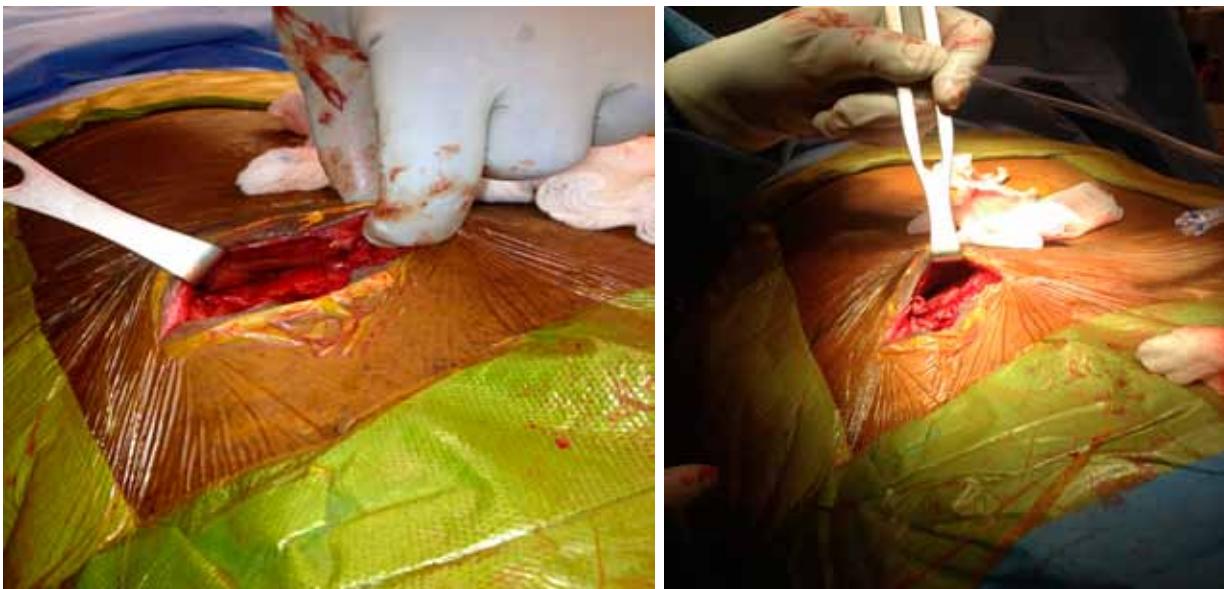
Fig. 2. *Intra-operative evidence of fibrous capsule build-up around the pulse generator.*

on the subcutaneous tissue. The device implanted in our patient had a larger size compared to newer generations of IPGs. We did not consider superficial implantation as a possible factor because the generator was originally implanted about 3 cm deep, securely anchored with non-resorbable sutures, the surgical wound was closed with 3 layers, and the patient had no complications for 3 years after the implantation.
