Anatomic Technical Report

## Sacral Vertebral Augmentation: Confirmation of Fluoroscopic Landmarks by Open Dissection

Andres Betts, MD

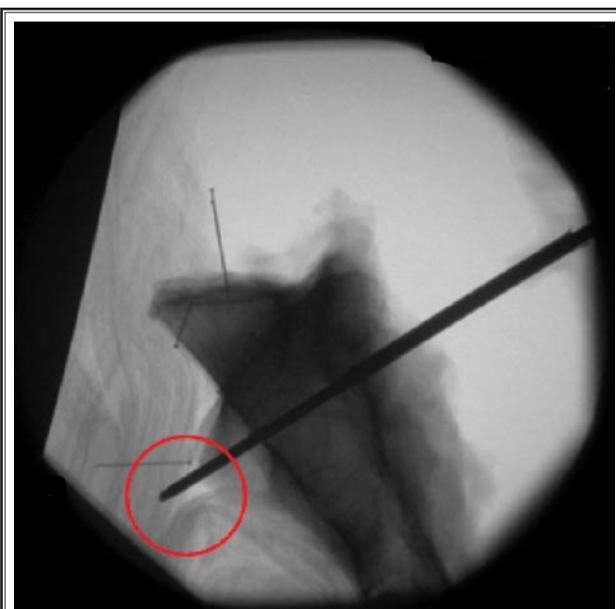
Fig 5. Fluoroscopic view of the cannula tip breaching the anterior surface of the inferior ala.

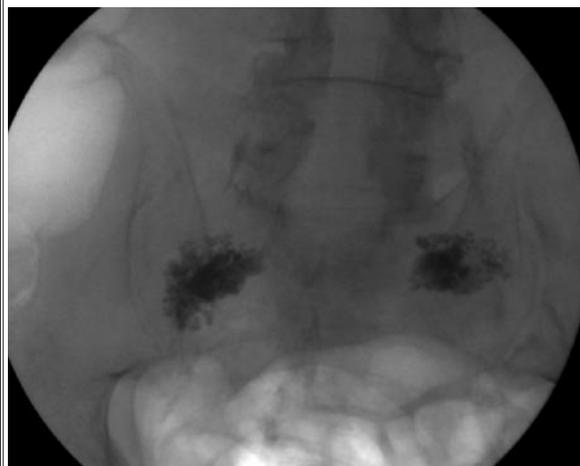
Fig. 14. Cement deposition into the lateral compartments of the sacrum in a patient with bilateral sacral insufficiency fractures AP view.

the cannulas. The PMMA cement did indeed flow into the region where the internal osteotomies were performed and with more directional control away from the sacral foramen (Fig. 14). The procedure was successfully performed with a single cannula and osteotomy per side with excellent spread of cement deposition.
